# Field Quality Control Update

Efficiency First California

June 11, 2014

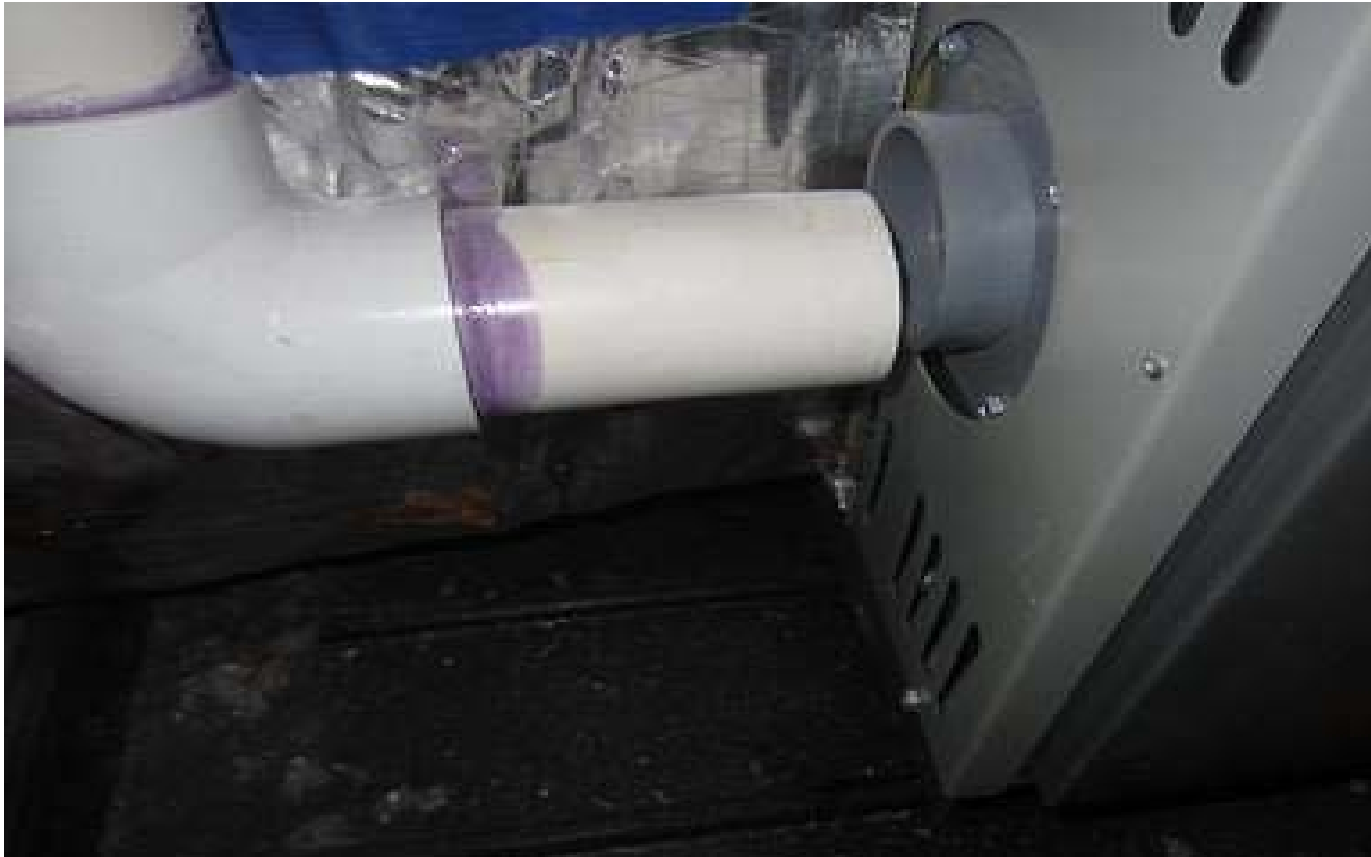
## Equipment — Disconnected Pipe

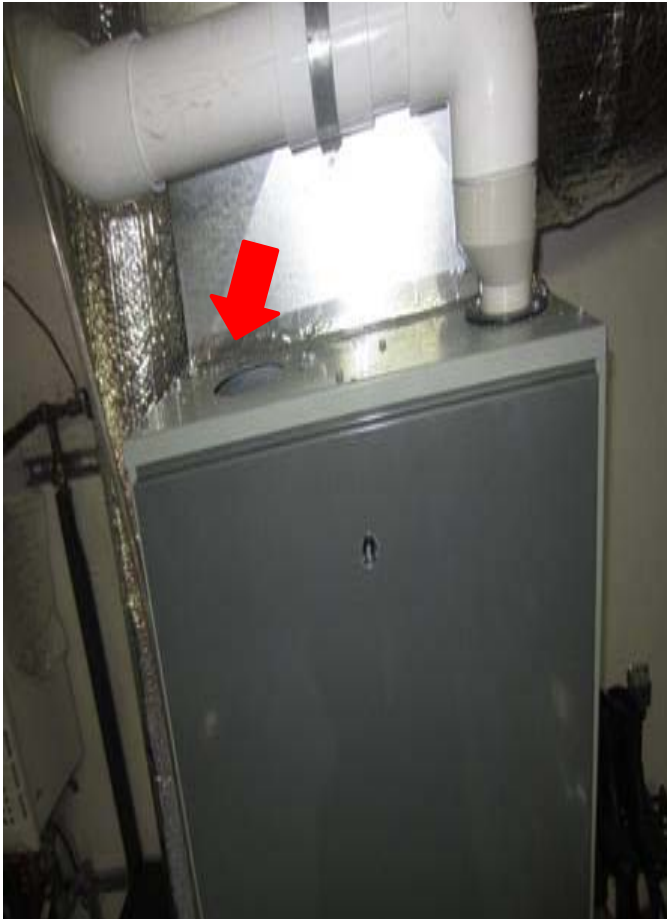
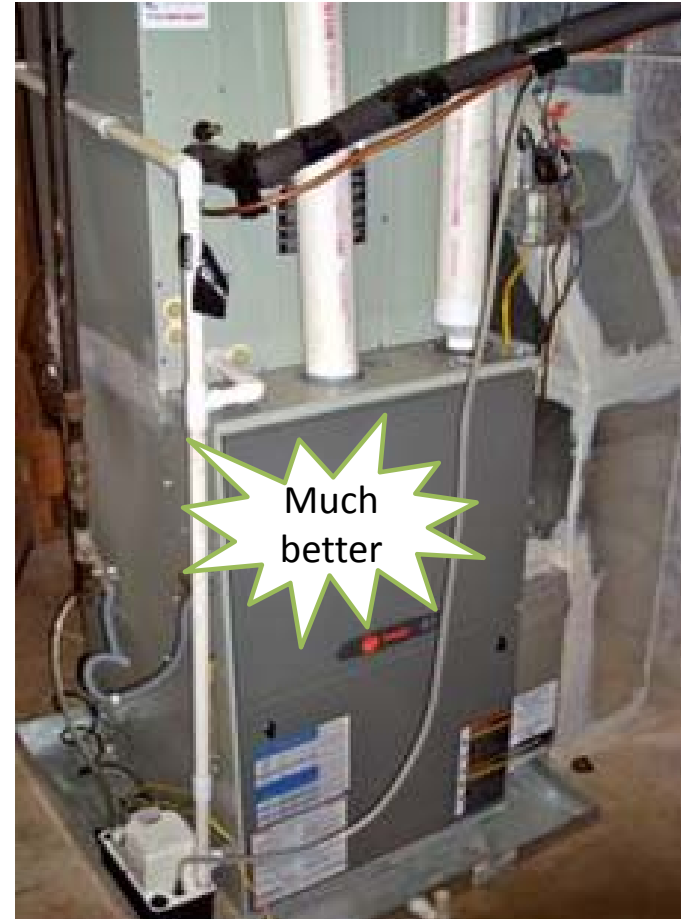
## Equipment — Furnace

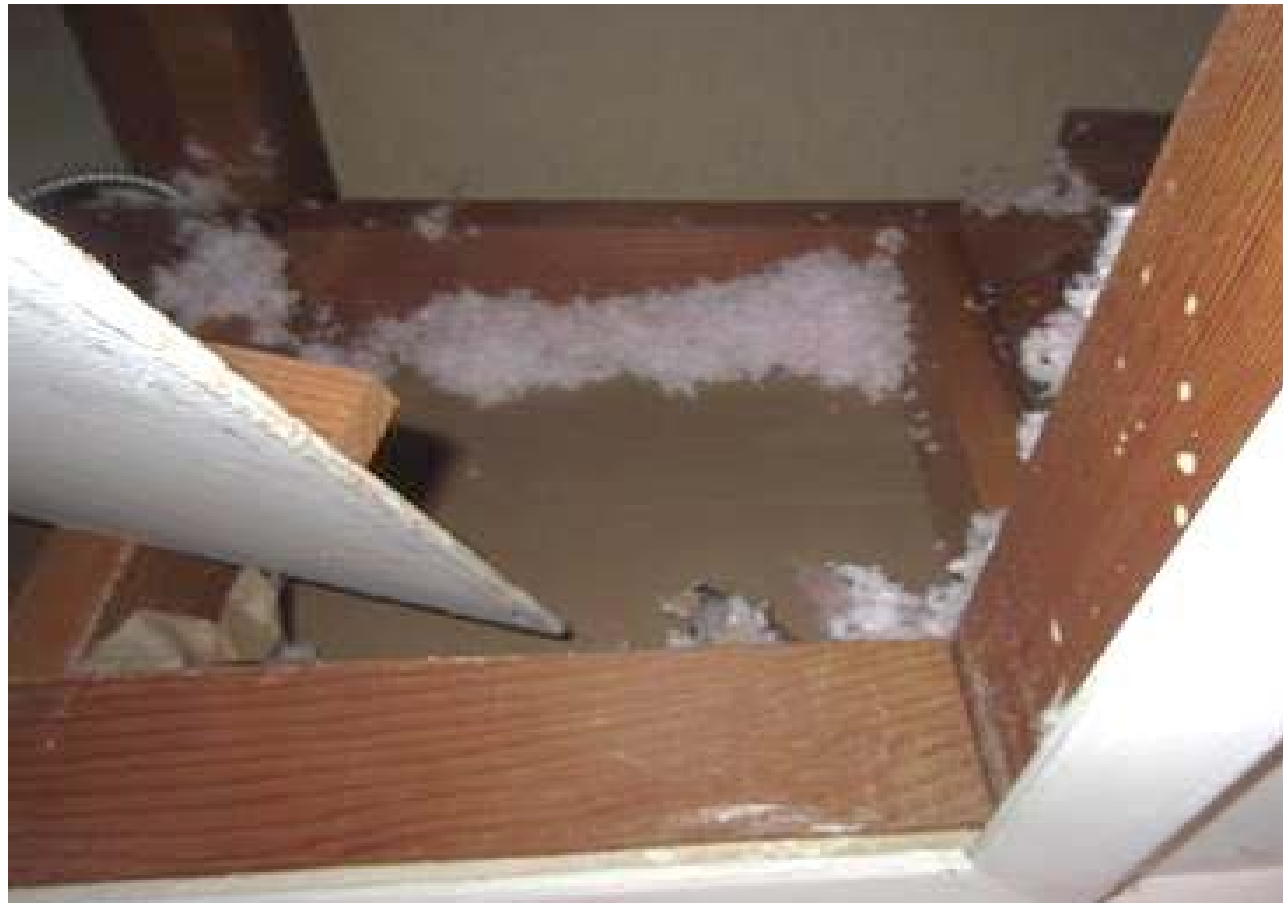
## Attic — Missing Insulation

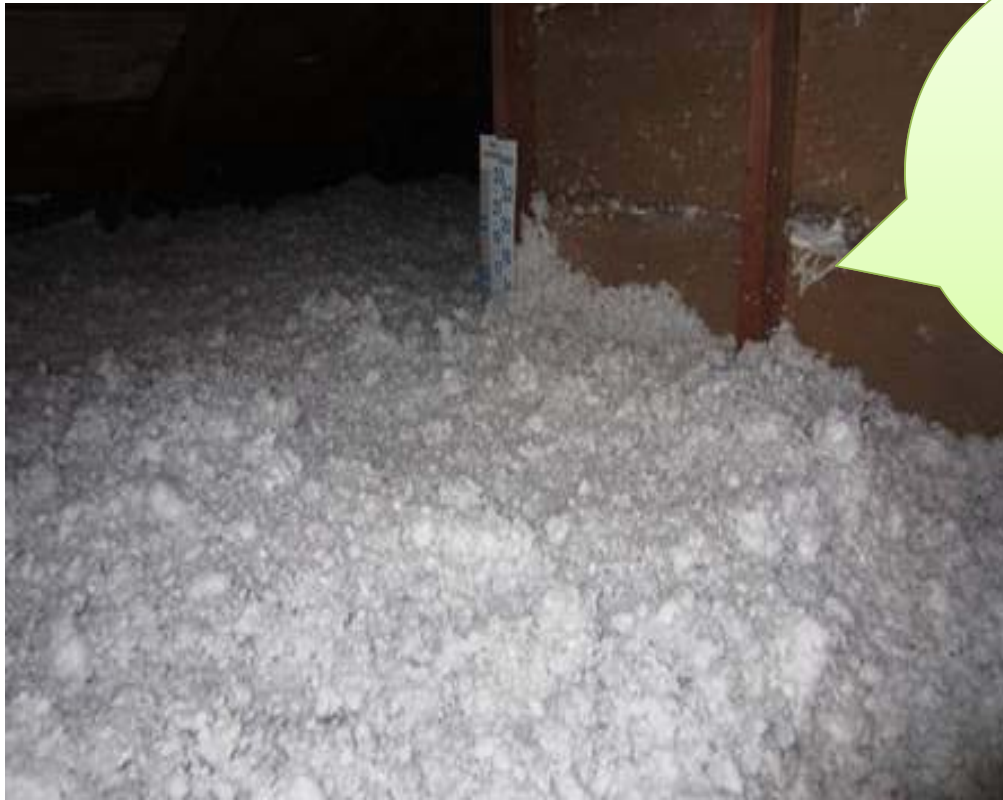
## Attic — Knee Wall Not Insulated

Insulate me  
to R-19  
please

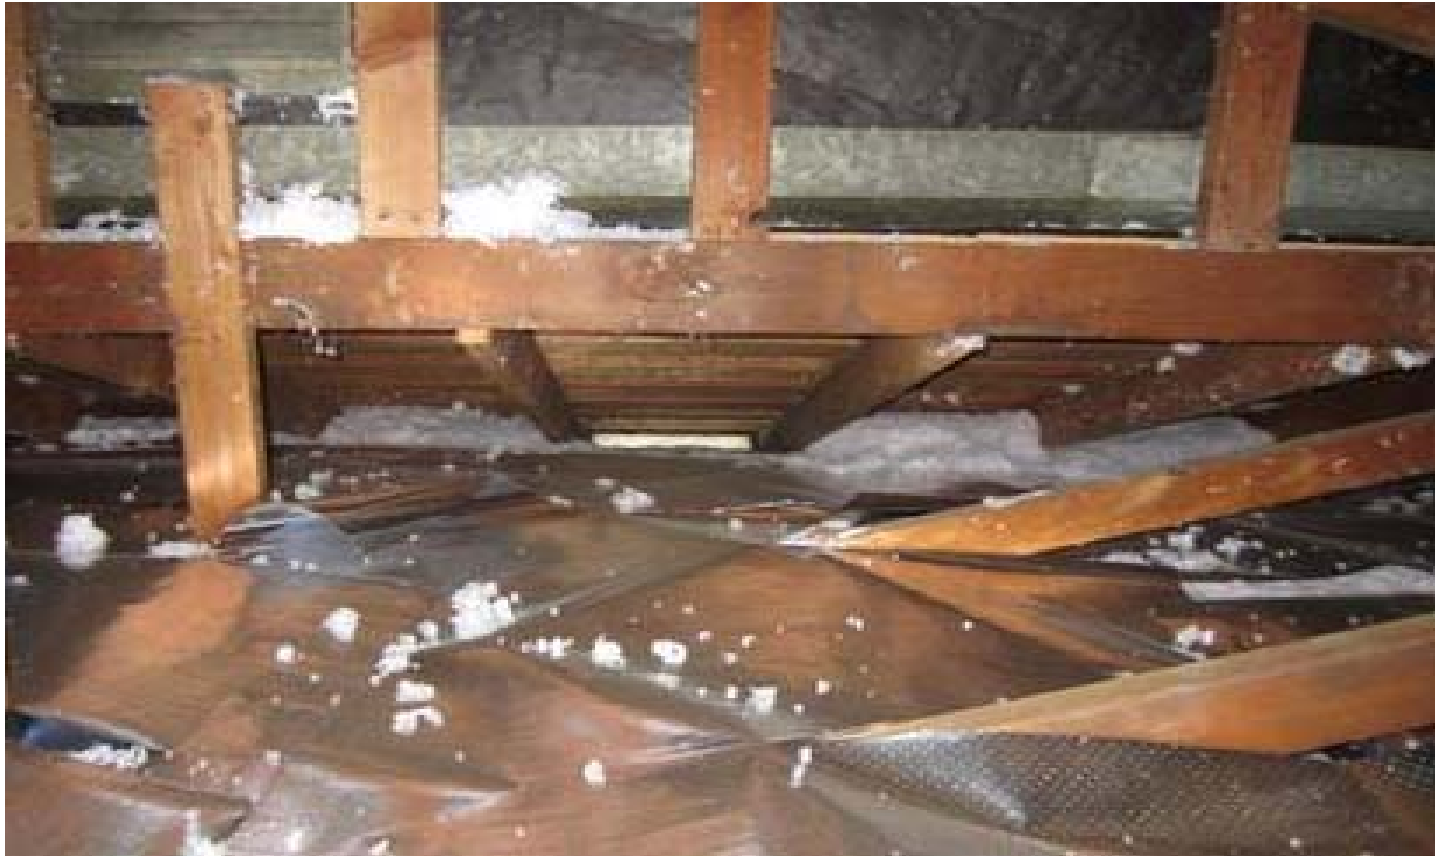
## Attic — Do Not Use Radiant Barrier

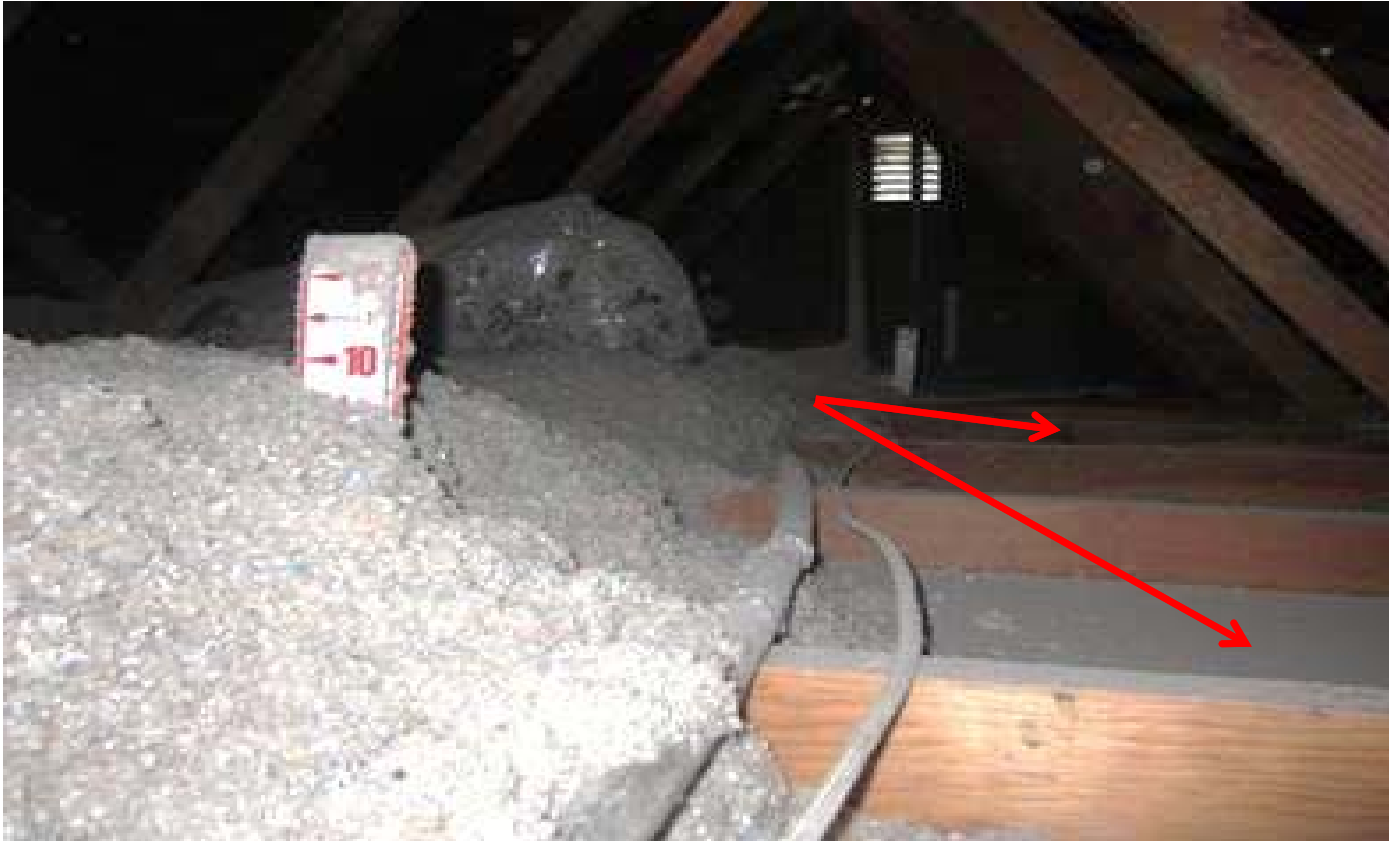
## Attic — Missing Insulation

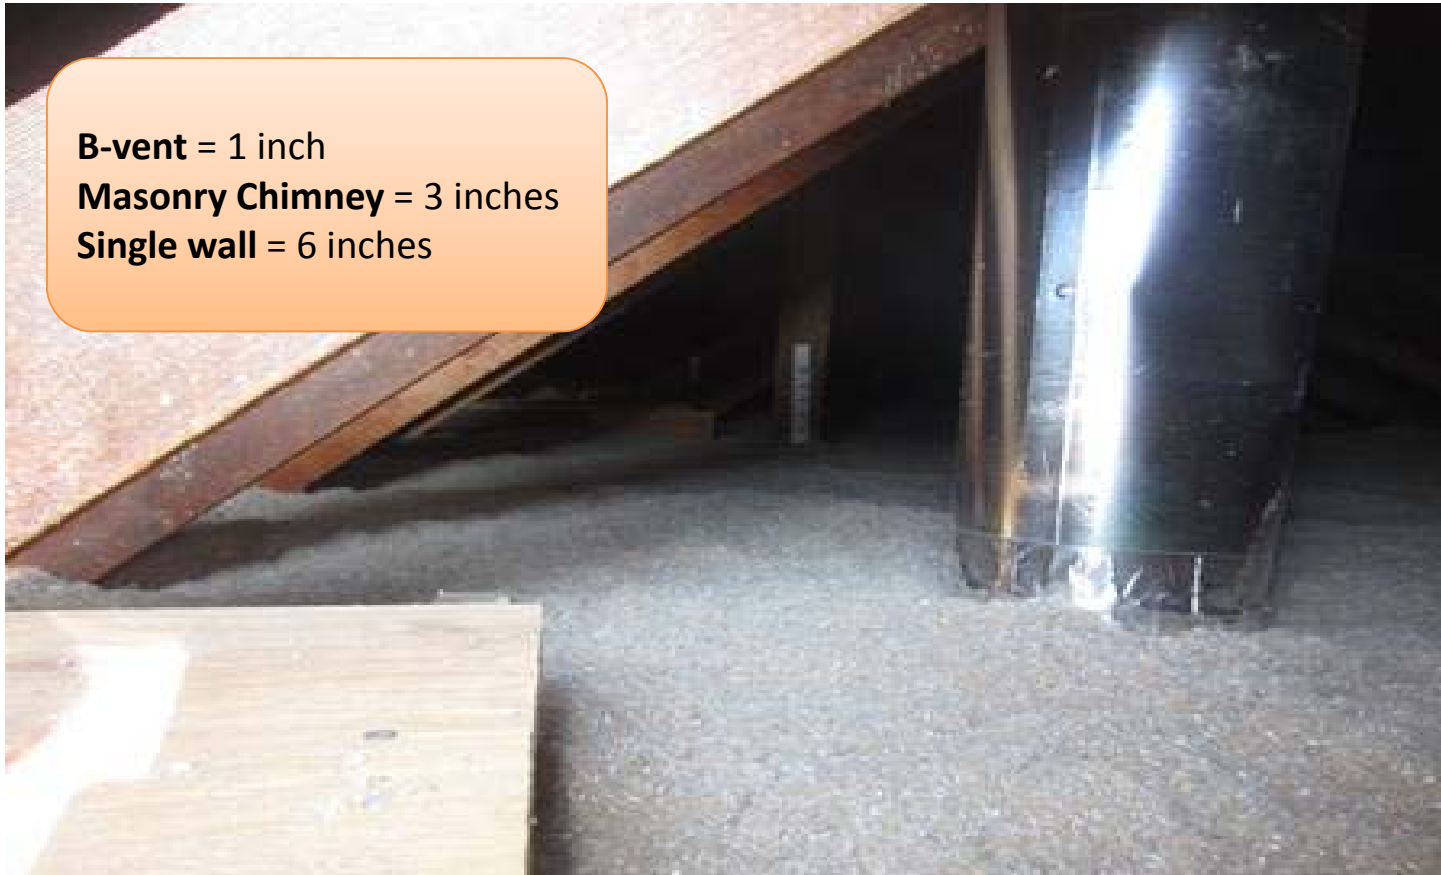
## Attic — No Fire Clearance

**B-vent** = 1 inch  
**Masonry Chimney** = 3 inches  
**Single wall** = 6 inches

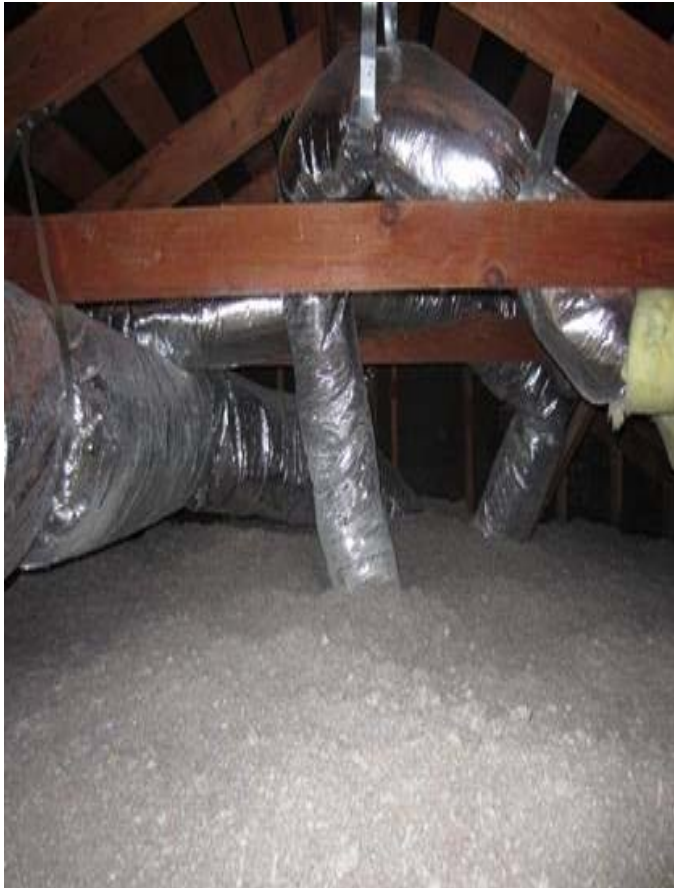
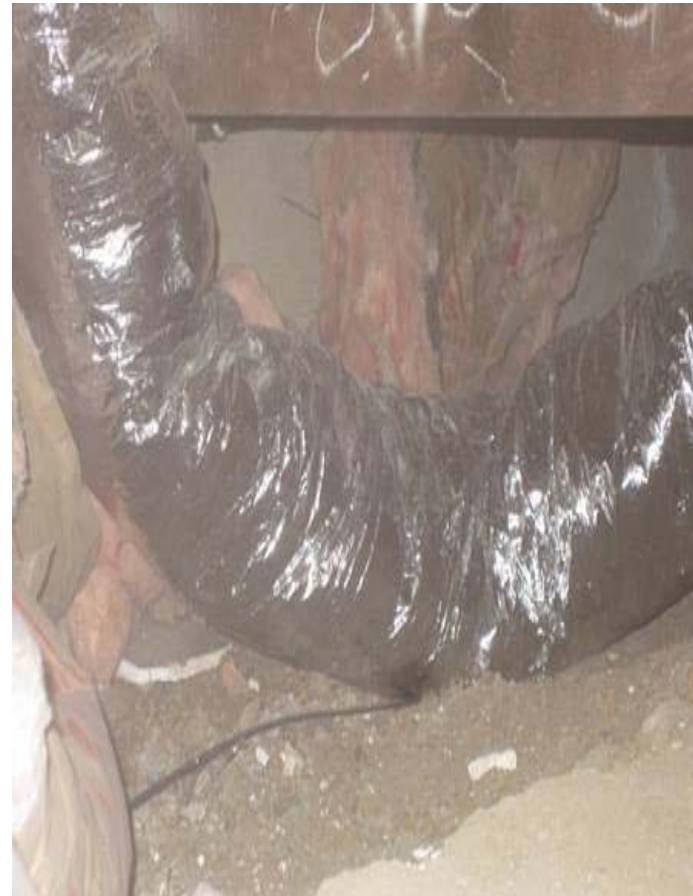
## Bad Ductwork

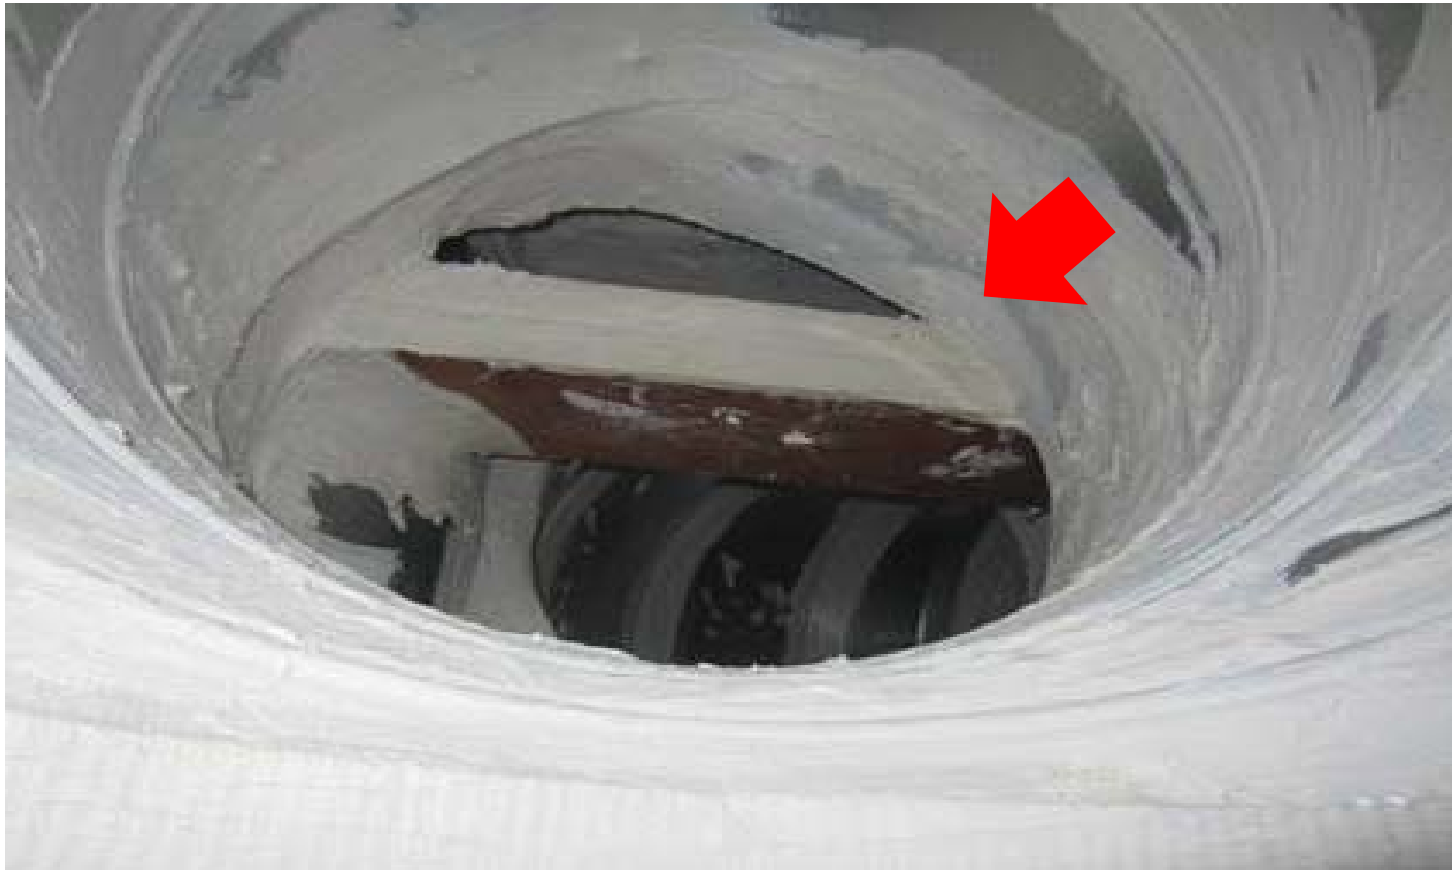
## Ductwork — Restricted

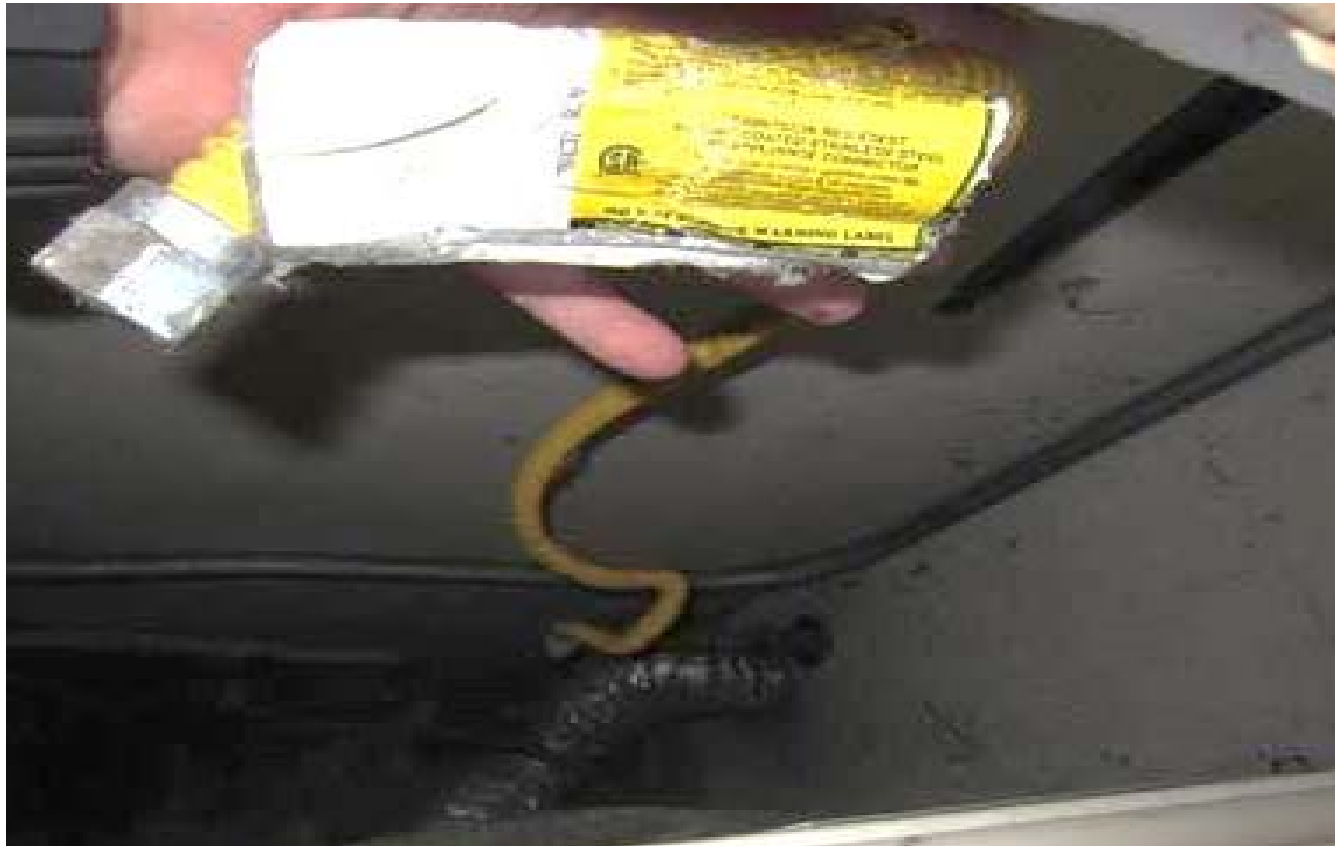
## CAS — Gas Line Not Capped

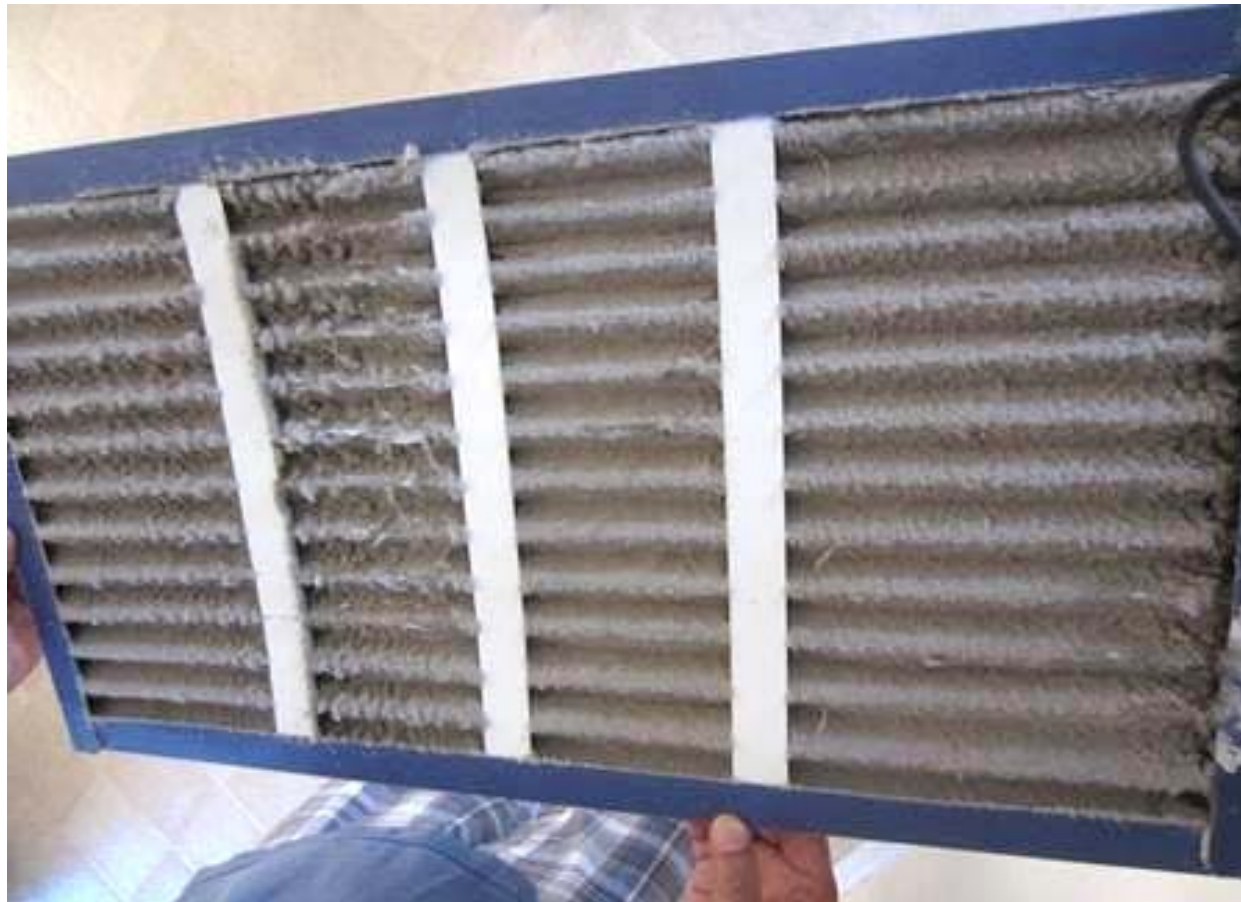
## Filter — Not Changed

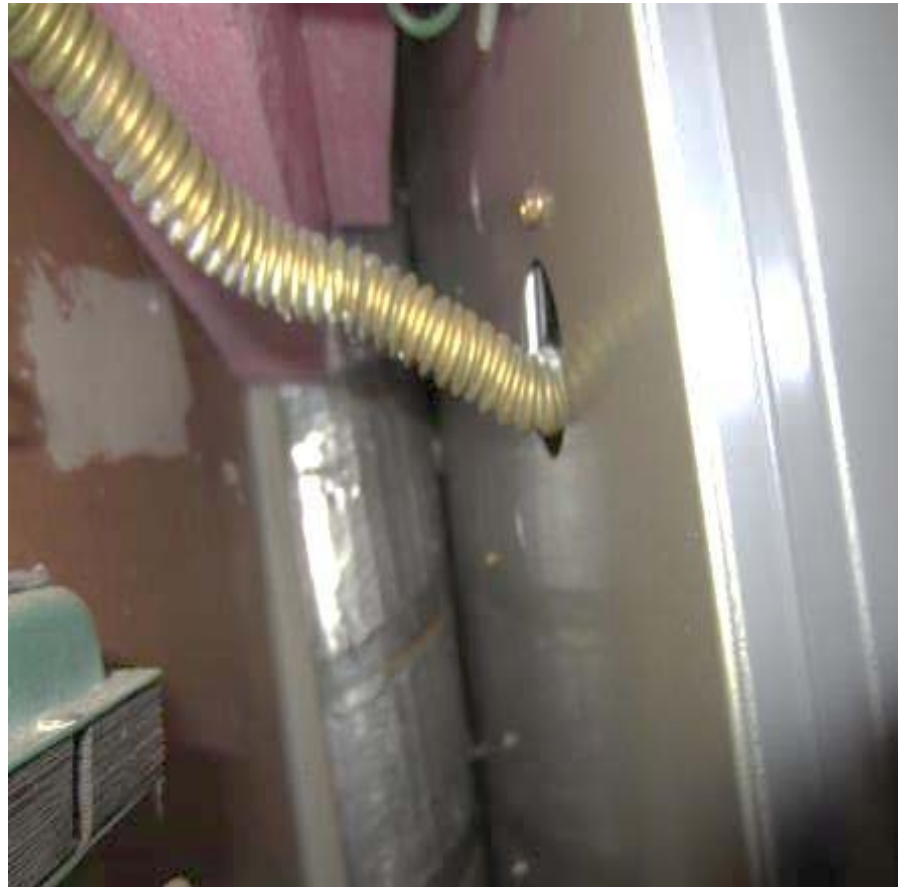
## Gas Line — Pre-1973

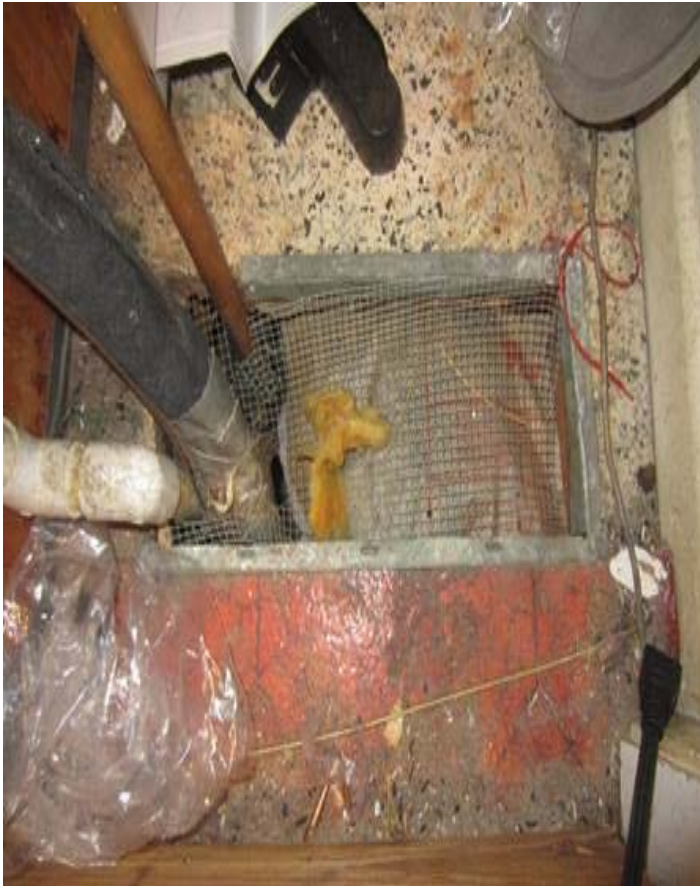
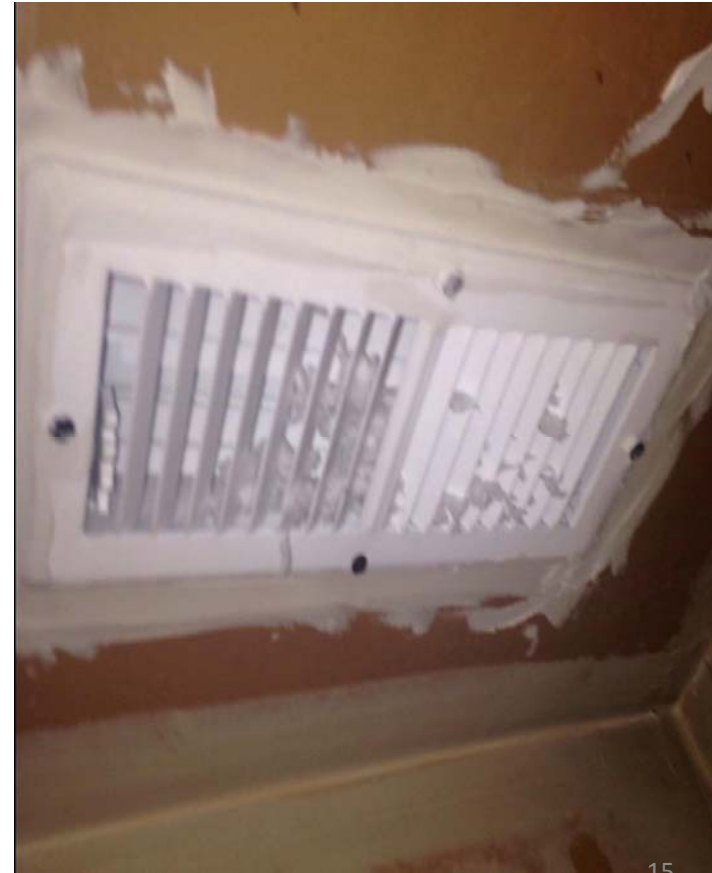
## CAS — Clogged Register

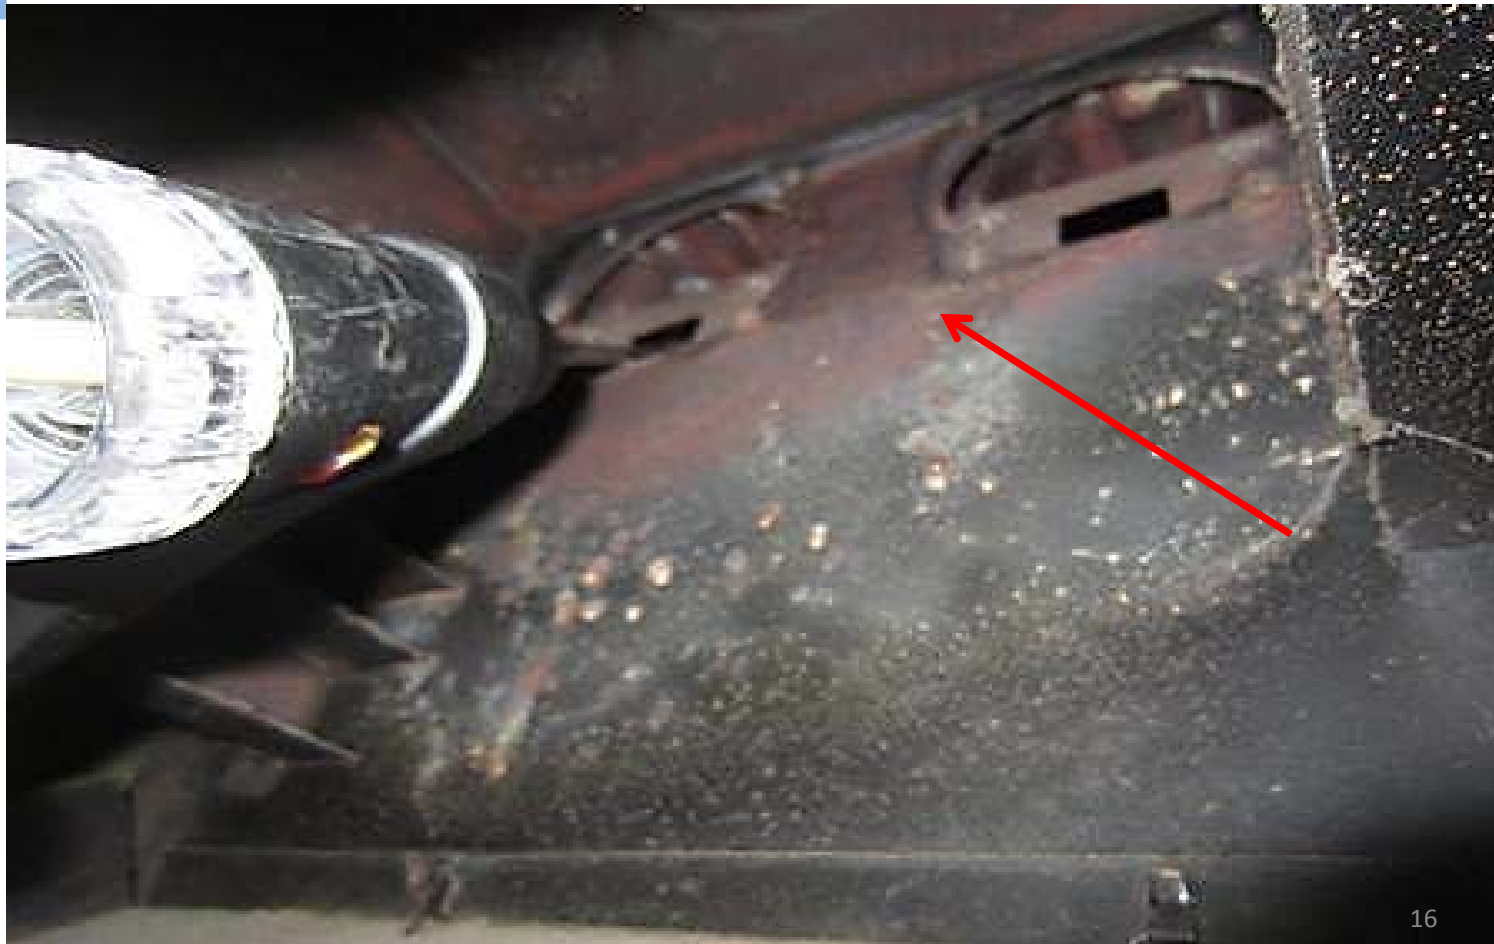
## CAS — Sign of Spillage

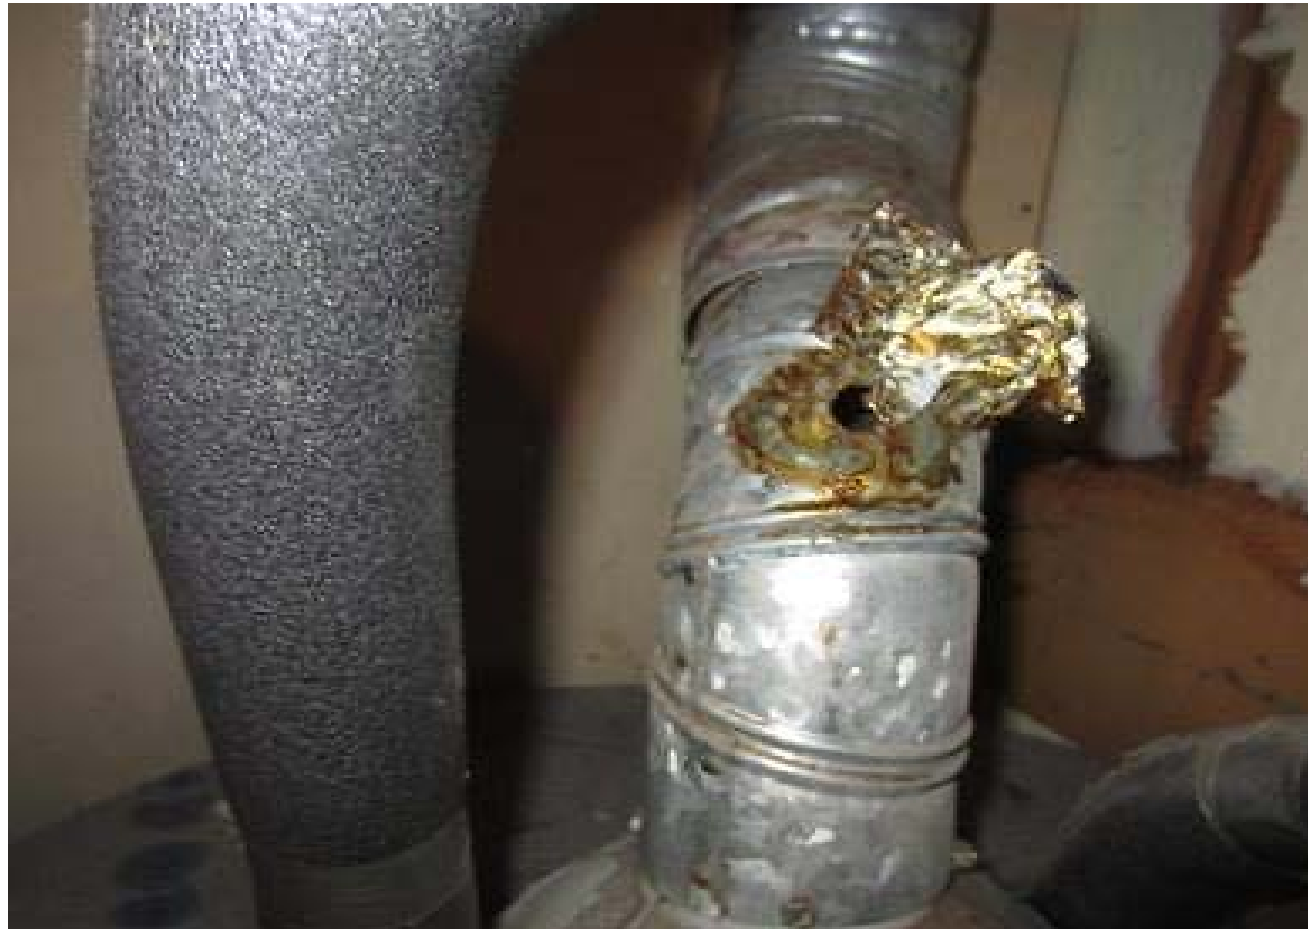
## CAS — Sign of Spillage

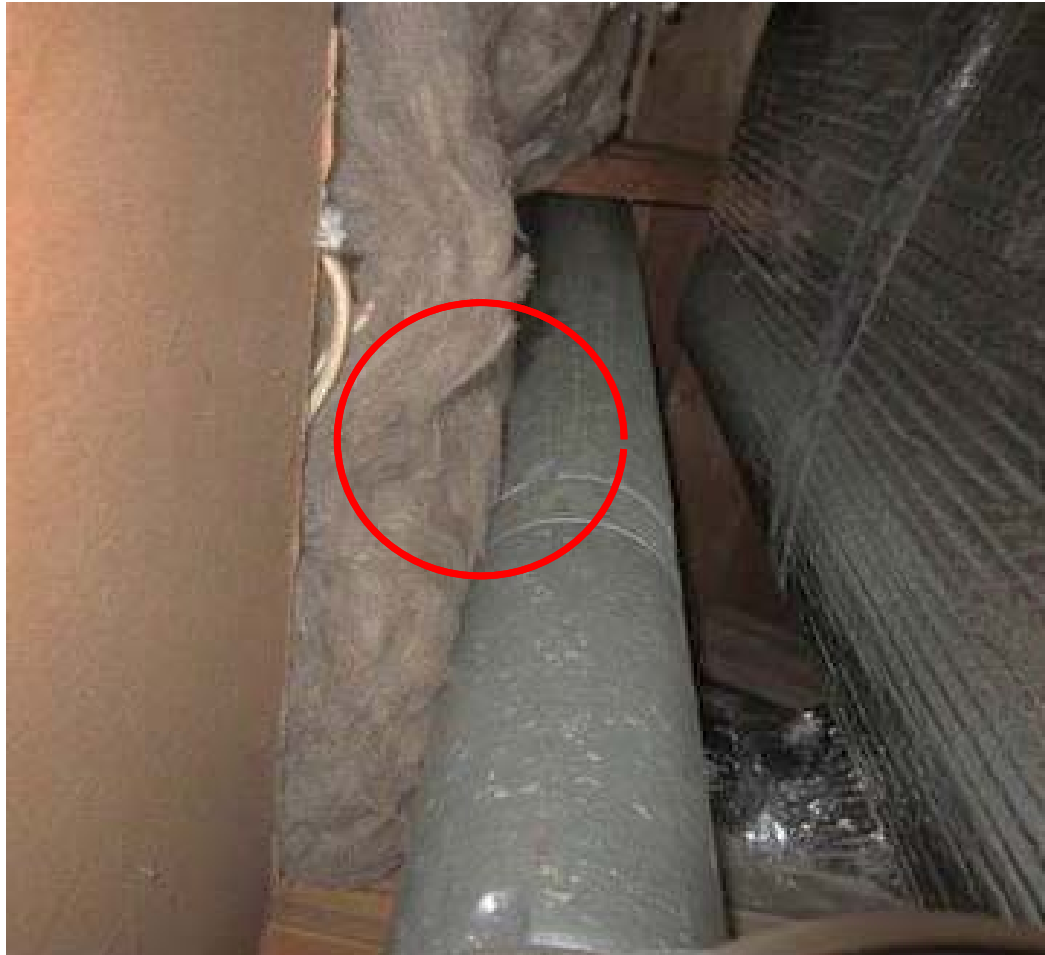
## No Fire Clearance

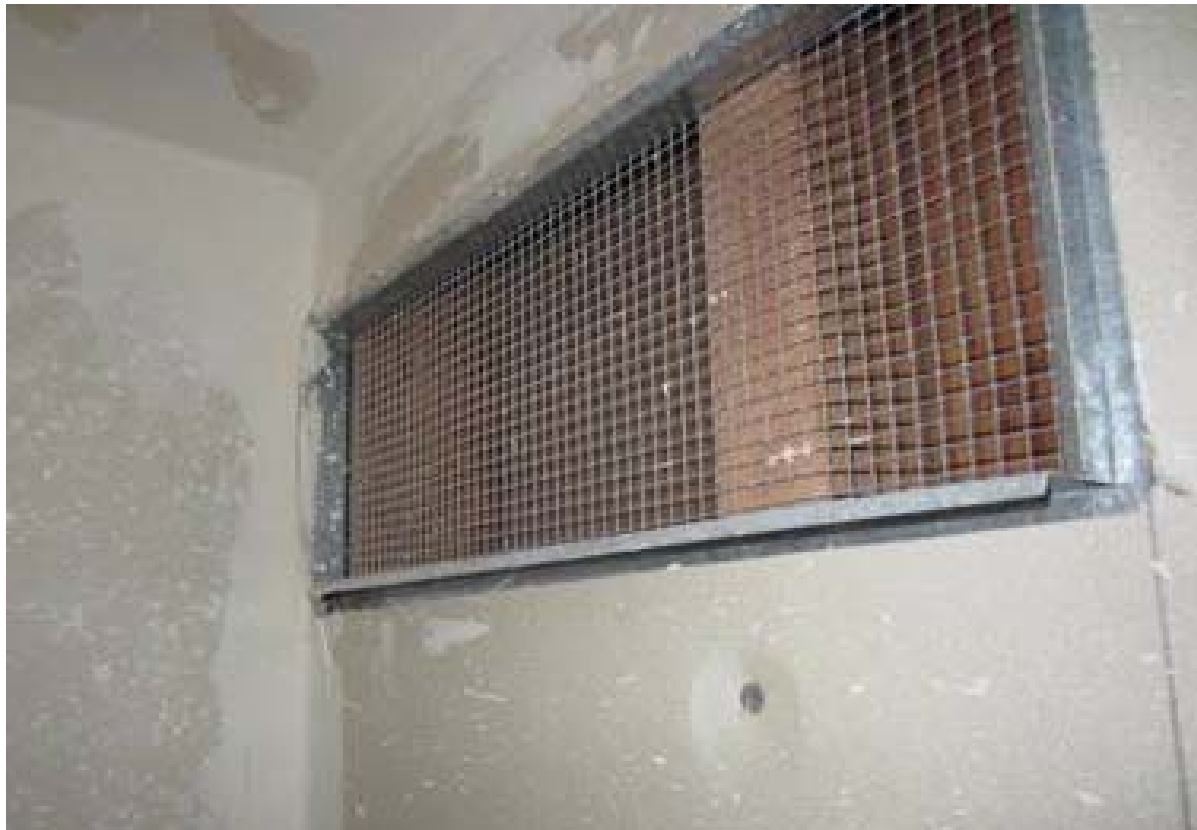
## CAS — No CVA

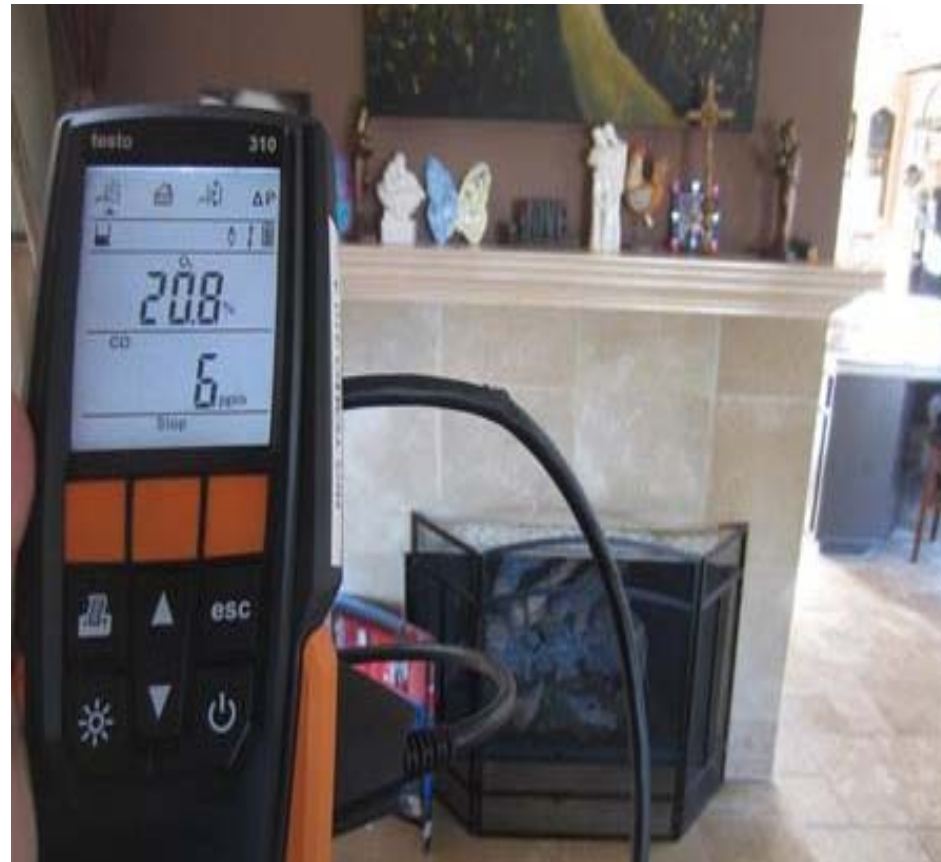
# CAS — Higher CO Reading at Fireplace

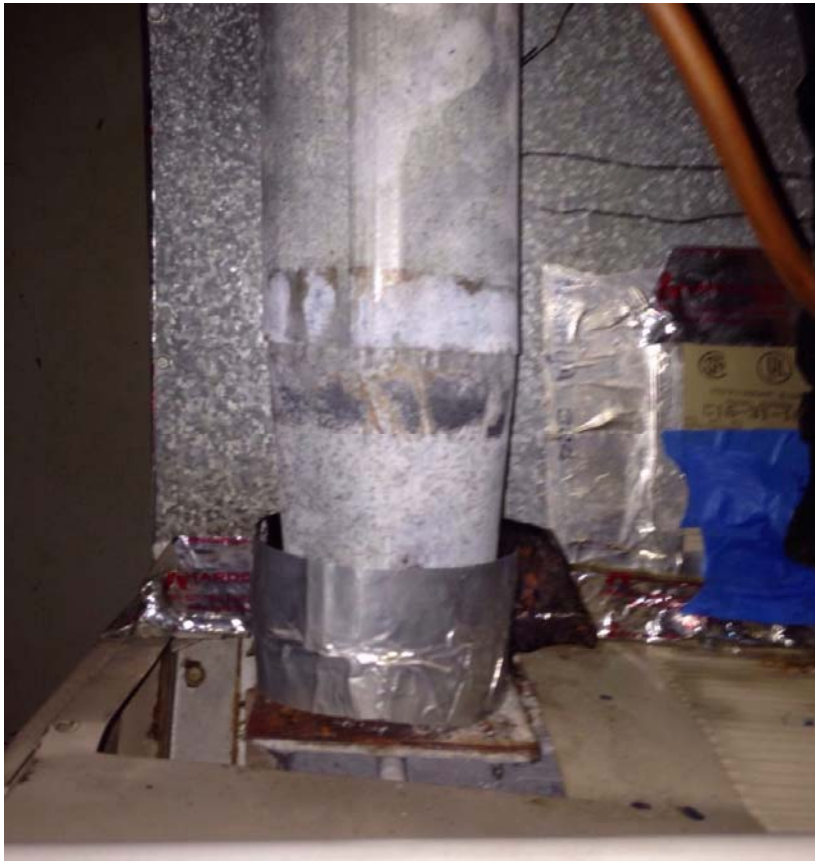
## CAS — Pipe Connections Not Fastened

- Three Screws
- No gaps

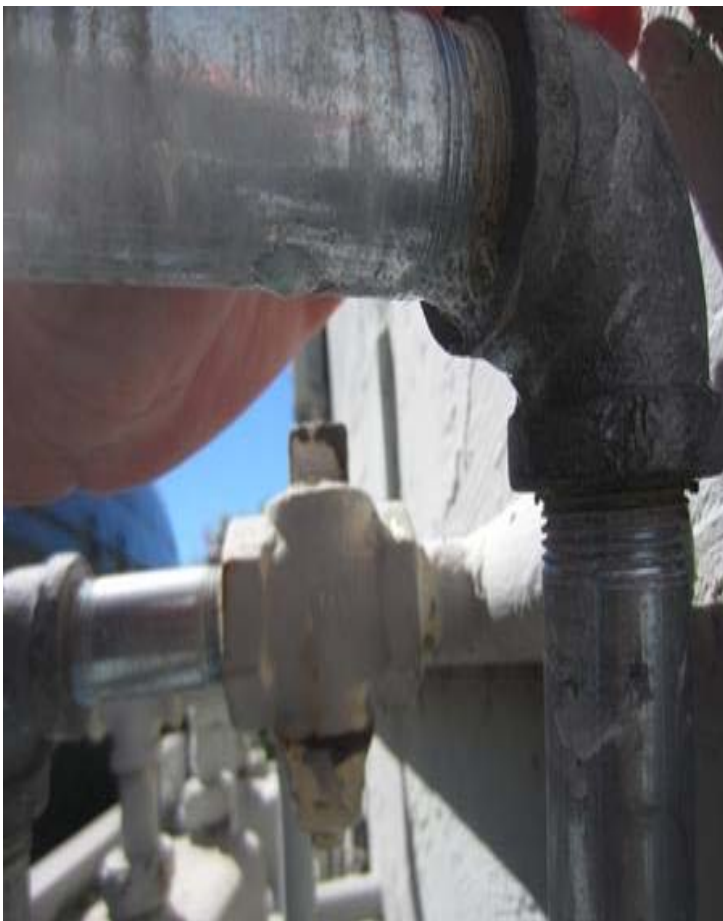
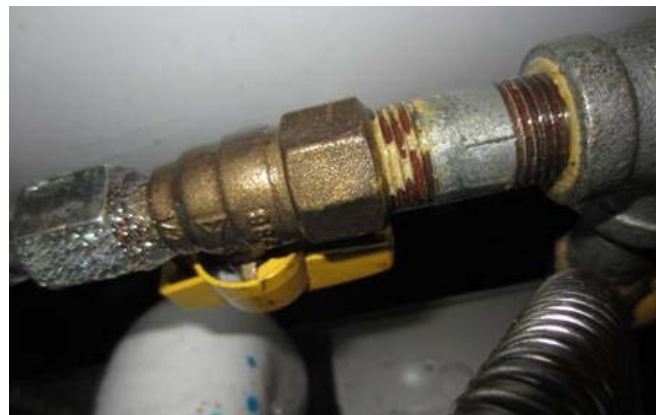
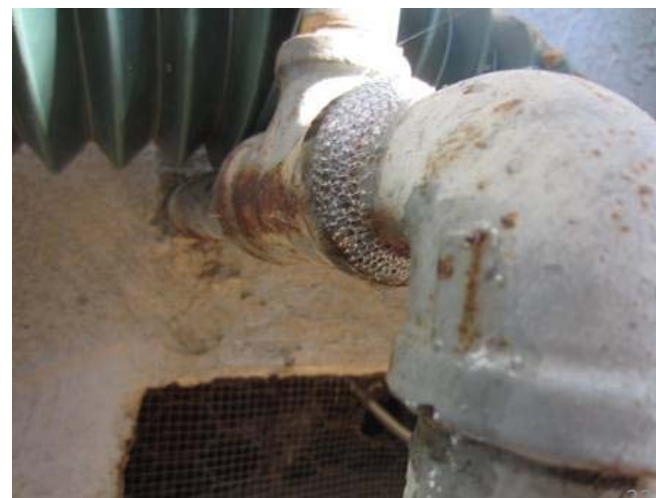
# Gas Leaks
