# Field Quality Control Update

Efficiency First California

June 11, 2014

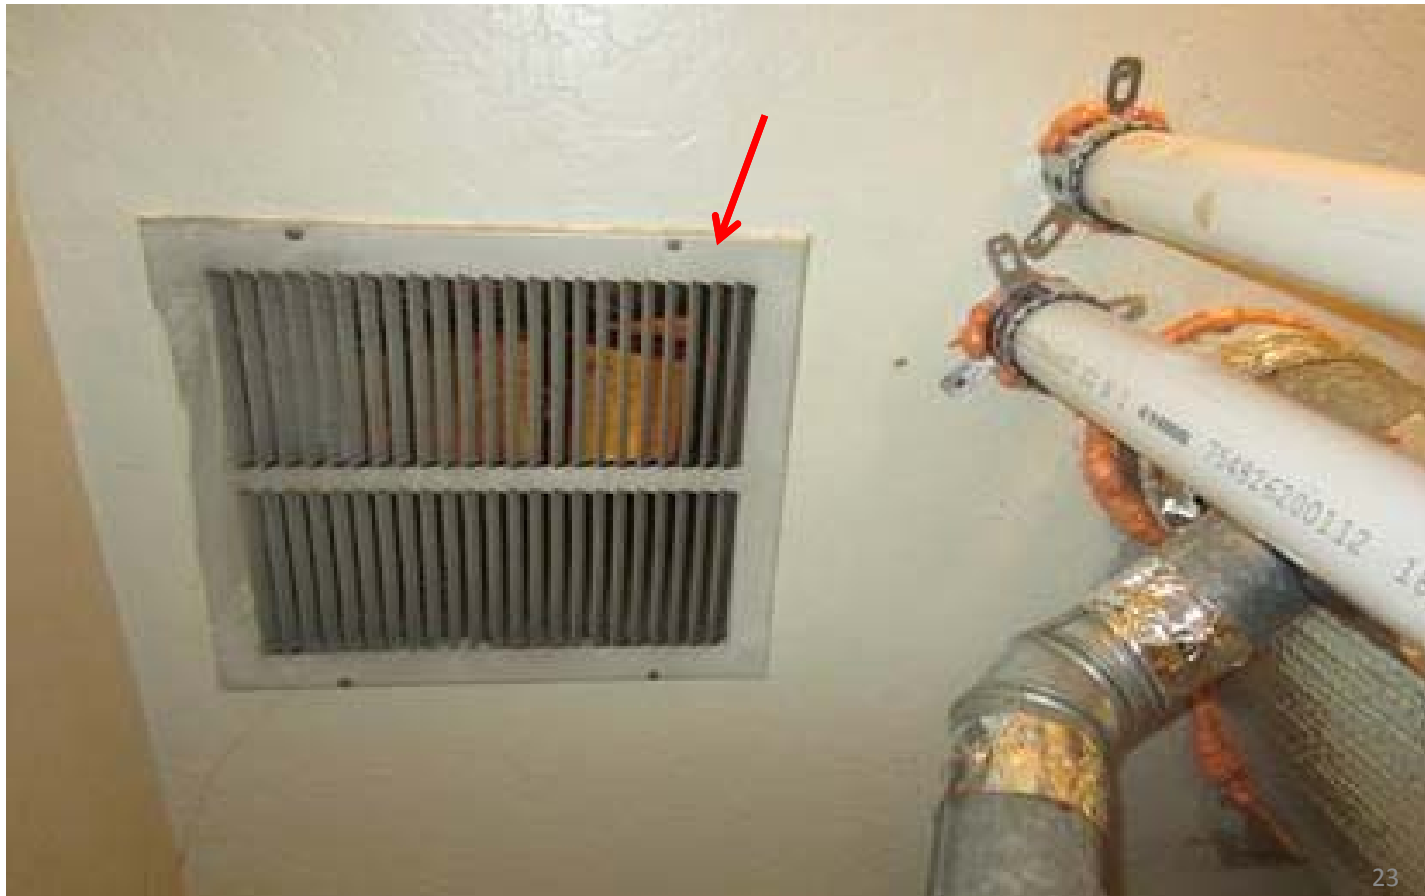
# No Air Sealing!

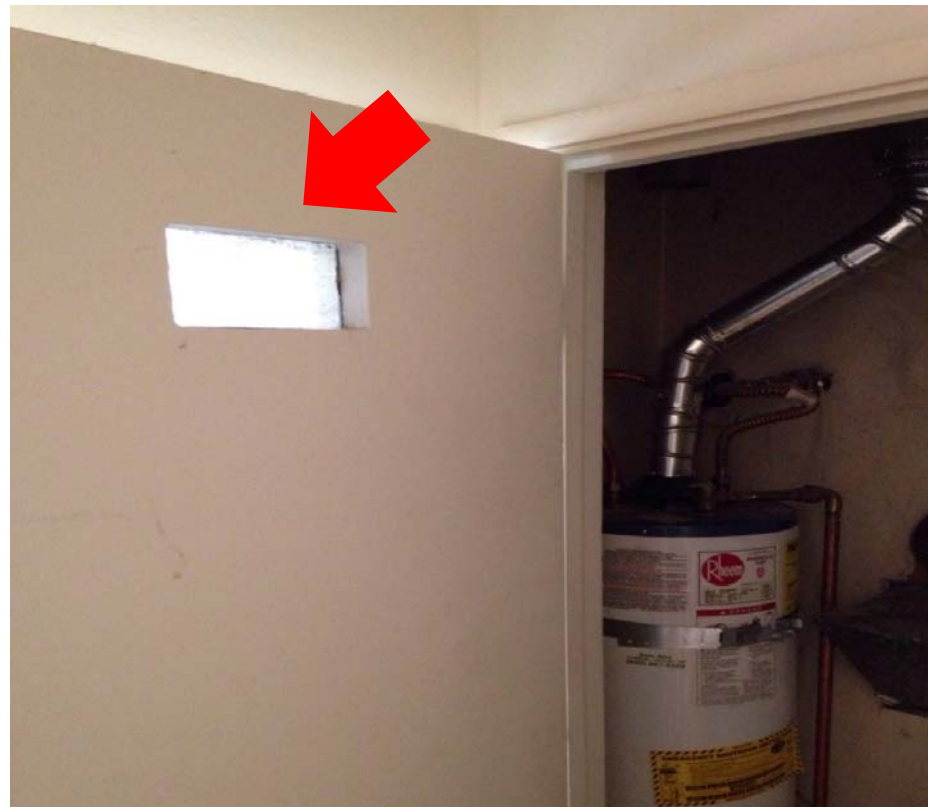
## CAS — Communication Issue

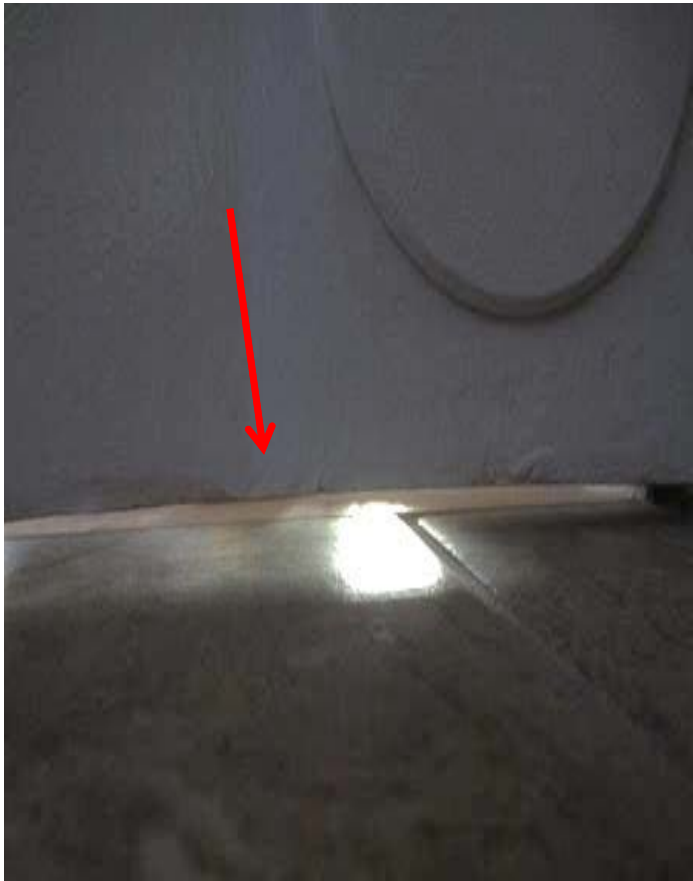
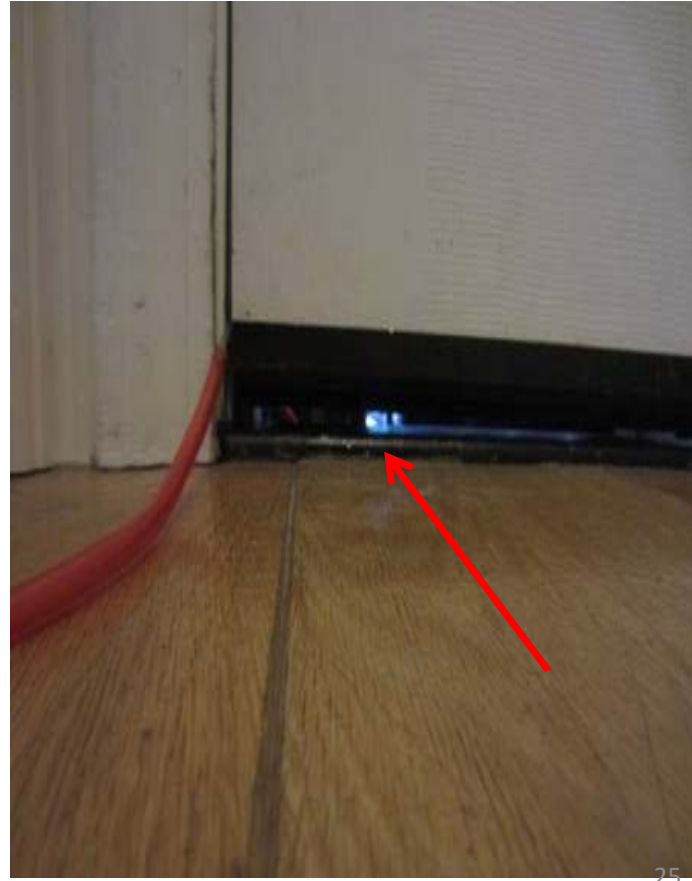
## Air Sealing — No Weather-Stripping
